Manhole Inspection Summary

Manhole # S29Q1_005MH

Insp Date: **2/21/08 9:28 AM**

Location Address: **1001 Cherry Hill Road**

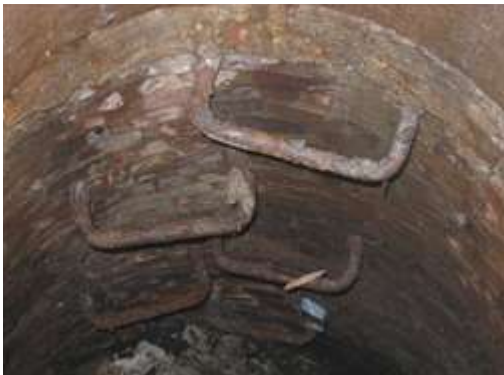
Steps

Count: **5** Missing: **0** ☒ **Corroded**

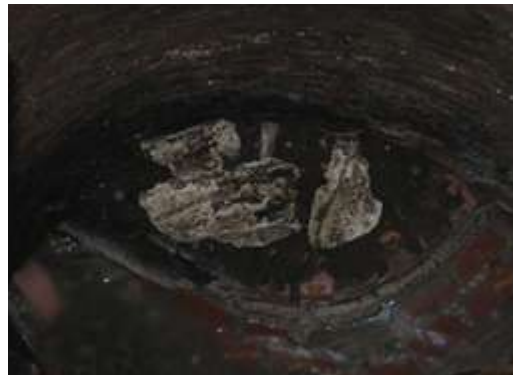
Defect 2

Condition: ☐ Sound ☐ Cracked ☐ Root Intrusion ☐ Deteriorated ☐ Leaks ☒ **Debris**

Bench

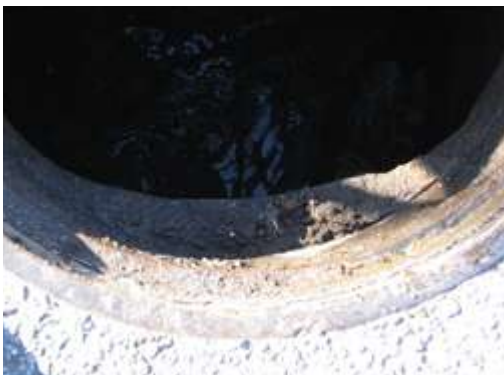
Defect 1

Offset: **2.5** (in.)

Frame offset

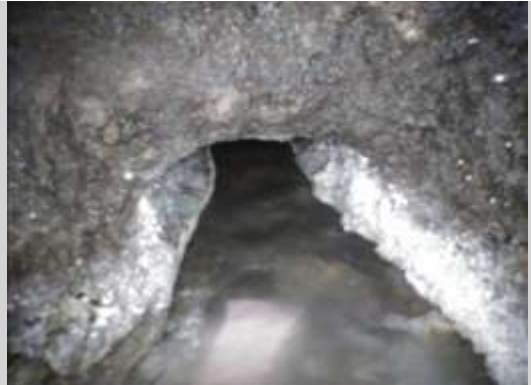
12 O'Clock Outflow

10 in. Circular Gravity Sewer
Pipe Out @ 12 O'Clock

Pipe Height: **9.6** (in.) Rod and Bar (Angled)
Pipe Material: **Clay** ☐ Pipe Lined
Invert Depth: **9.14** (ft.) Flow Characteristics: **Fast**
Deposits: ☒ None ☐ Mud ☐ Sludge ☐ Debris ☐ Grease
Silt Depth: (in.) Deposits Extent:
Infiltration: **None** Pipe Seal Cond: **Sound**

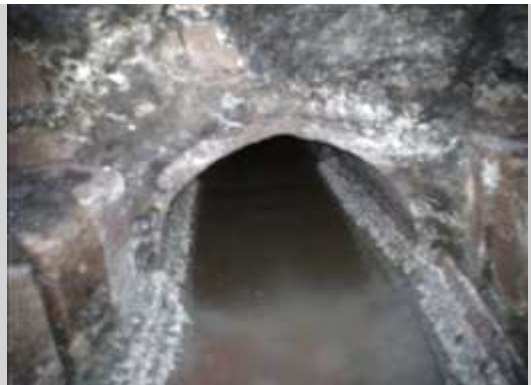
3 O'Clock Inflow

8 in. Circular Gravity Sewer
Pipe In @ 3 O'Clock

Pipe Height: **8.4** (in.) Rod and Bar (Angled)
Pipe Material: **Clay** ☐ Pipe Lined
Invert Depth: **9.05** (ft.) Flow Characteristics: **Slow**
Deposits: ☒ None ☐ Mud ☐ Sludge ☐ Debris ☐ Grease
Silt Depth: (in.) Deposits Extent:
Infiltration: **None** Pipe Seal Cond: **Sound**

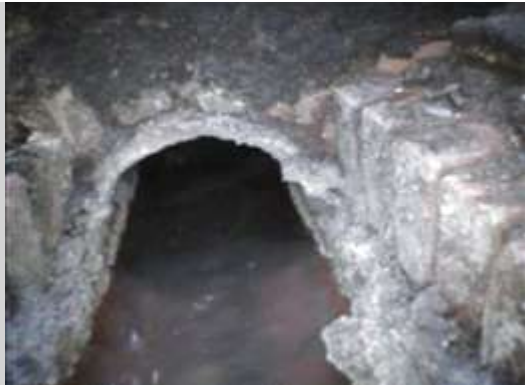
6 O'Clock Inflow

Pipe Height: **9.6** (in.) Rod and Bar (Angled)

Infiltration: **None** Pipe Seal Cond: **Sound**

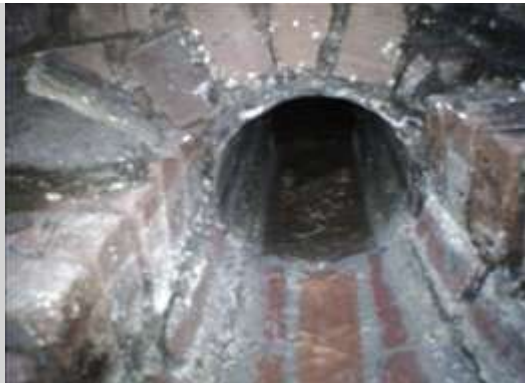
9 O'Clock Inflow

Pipe Height: **9.6** (in.) Rod and Bar (Angled)

Infiltration: **None** Pipe Seal Cond: **Sound**
